Manhole Inspection Summary

Manhole # S17C1_001MH

Insp Date: **5/15/08 1:05 PM**

Location Address: **2801 letitia av**

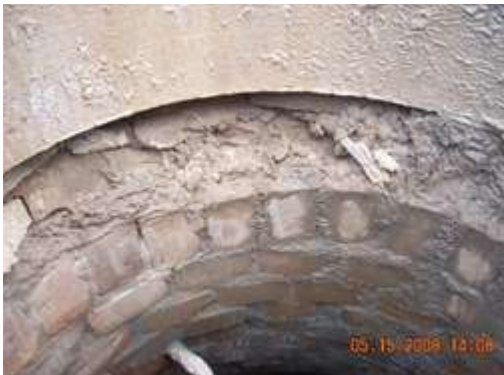
Defect 3

Condition: ☐ Sound ☐ Cracked ☐ Root Intrusion ☐ Loose Brick ☒ **Deteriorated**

deteriorated chimney

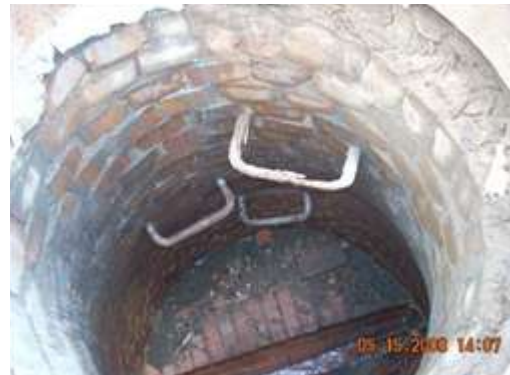
Defect 2

Count: **3** Missing: **0** ☒ **Corroded**

corroded steps, bench debris

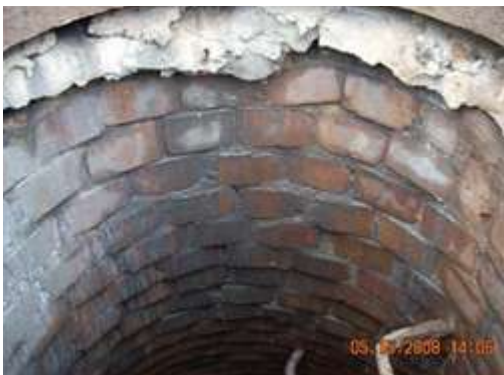
Defect 1

Infiltration: ☐ None ☒ **Joint** ☐ Cracks ☐ Mortar ☐ Roots ☐ Wall

infiltration @ chimney/frame joint

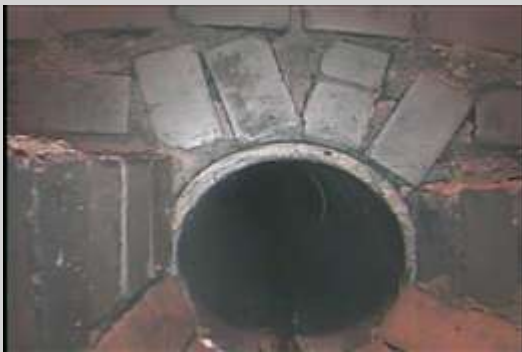
12 O'Clock Outflow

Pipe Height: **8.4** (in.) Rod and Bar (Angled)
Pipe Material: **Clay** ☐ Pipe Lined
Invert Depth: **7.58** (ft.) Flow Characteristics: **Slow**
Deposits: ☒ None ☐ Mud ☐ Sludge ☐ Debris ☐ Grease
Silt Depth: **0** (in.) Deposits Extent:
Infiltration: **None** Pipe Seal Cond: **Sound**

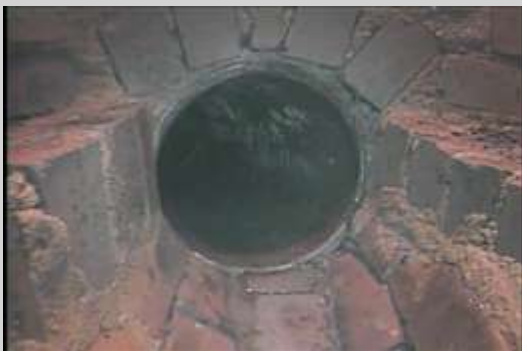
3 O'Clock Inflow

Pipe Height: **8.4** (in.) Rod and Bar (Angled)
Pipe Material: **Clay** ☐ Pipe Lined
Invert Depth: **7.13** (ft.) Flow Characteristics: **Slow**
Deposits: ☒ None ☐ Mud ☐ Sludge ☐ Debris ☐ Grease
Silt Depth: **0** (in.) Deposits Extent:
Infiltration: **None** Pipe Seal Cond: **Sound**

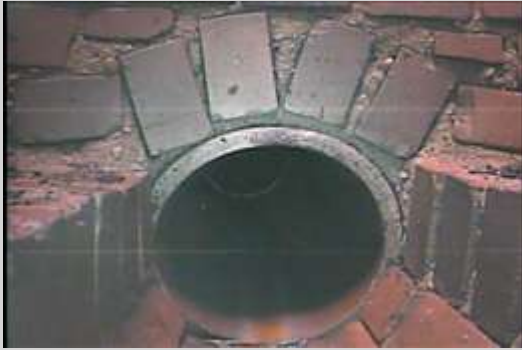
6 O'Clock Inflow

Pipe Height: **8.4** (in.) Rod and Bar (Angled)

Pipe Material: **Clay** ☐ Pipe Lined

Invert Depth: **7.39** (ft.) Flow Characteristics: **Slow**

Deposits: ☒ None ☐ Mud ☐ Sludge ☐ Debris ☐ Grease

Infiltration: **None** Pipe Seal Cond: **Sound**
